Opal, Ruby and Amber Court Residents' Meeting

26th February 2026

Explanation of building design

Appendix
Building structure supporting
technical information
by Pell Frischmann

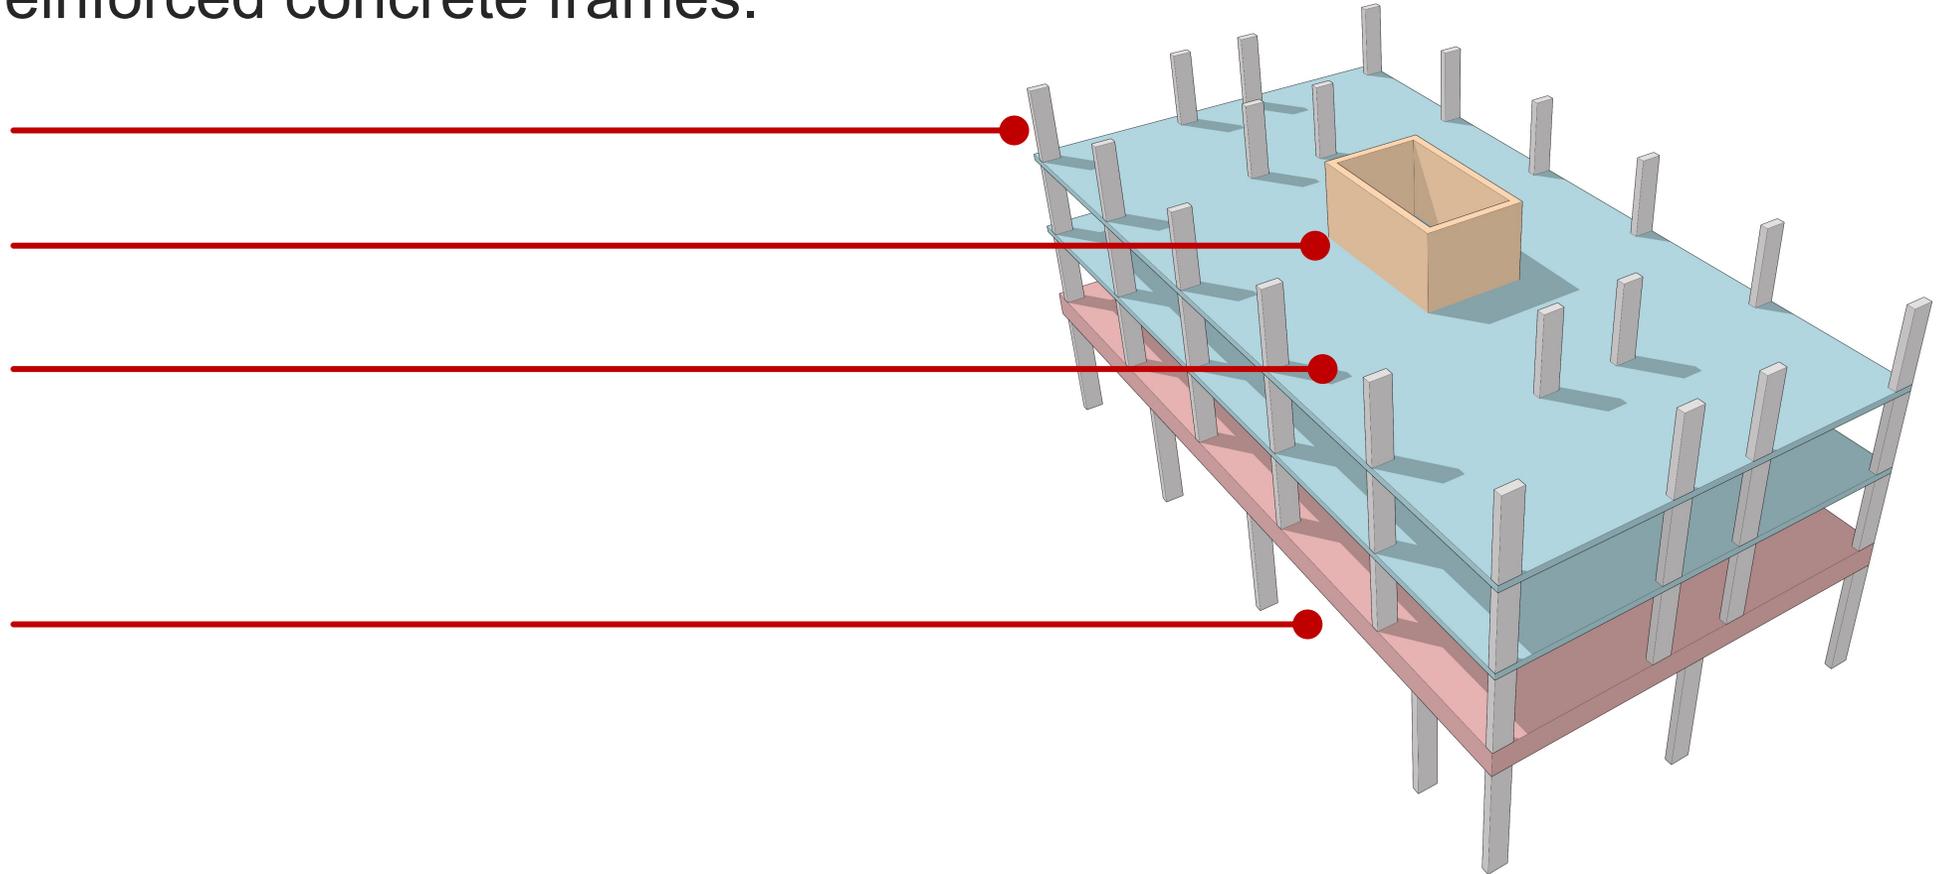
All Blocks are reinforced concrete frames.

Column

Core

Slab

Transfer slab

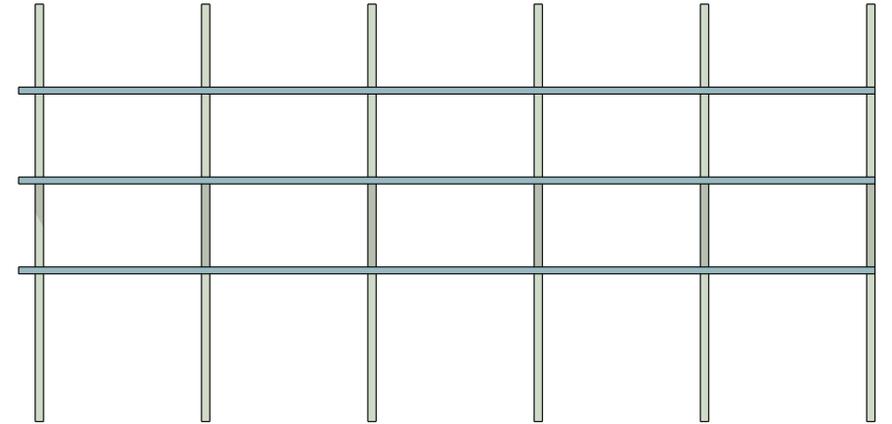
Vertically aligned

- Opal, Ruby and Amber Court are reliant on transfer slabs; the primary transfer slab is located at ground level.
- This is not an unusual form of structure for this type of building.
- It is often used to accommodate different floor layout requirements between basement/ground areas to those above such as residential layouts

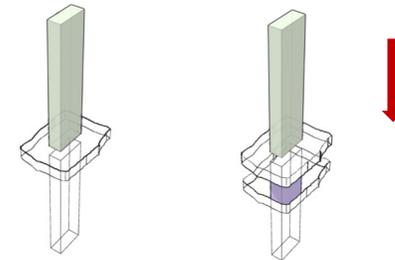
Punching shear – vertically continuous columns

- Column to slab punching shear concerns
- Slab combined punching shear and bending concerns

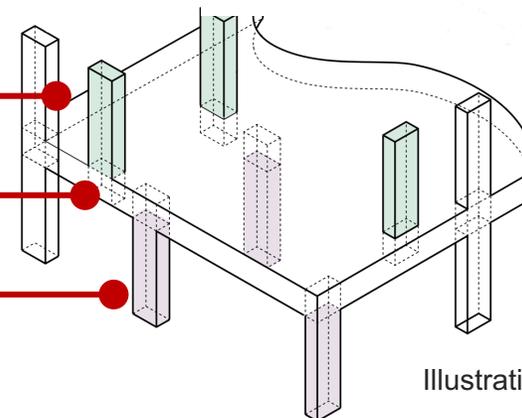
Transfer slab nomenclature and punching shear

Planted Column

Transfer slab

Supporting column

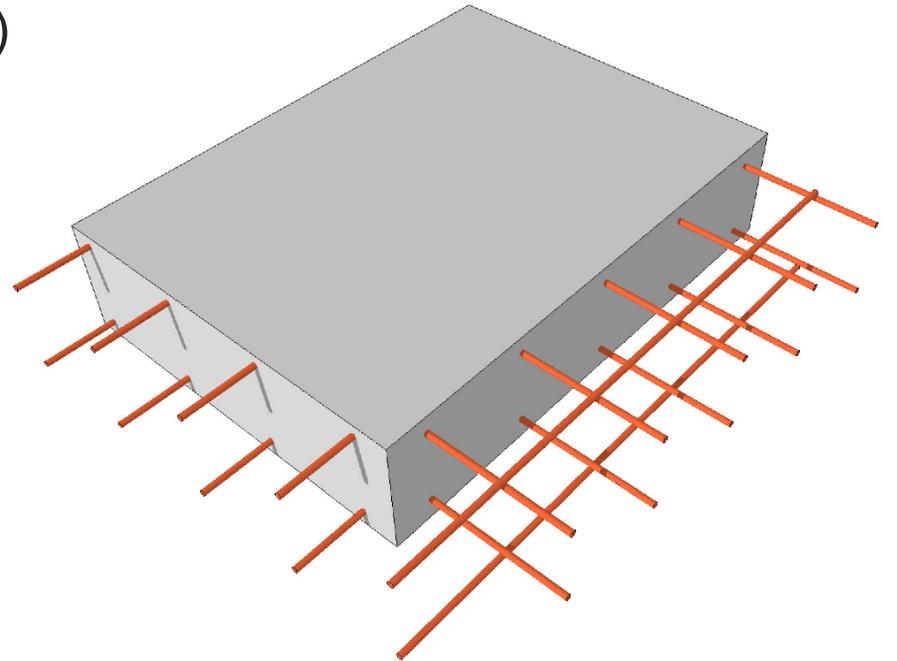
- Slab combined punching shear and bending concerns
 - Concrete is good in compression (being squeezed)
 - Concrete is poor in tension (being bent and stretched)
 - Steel is strong in tension

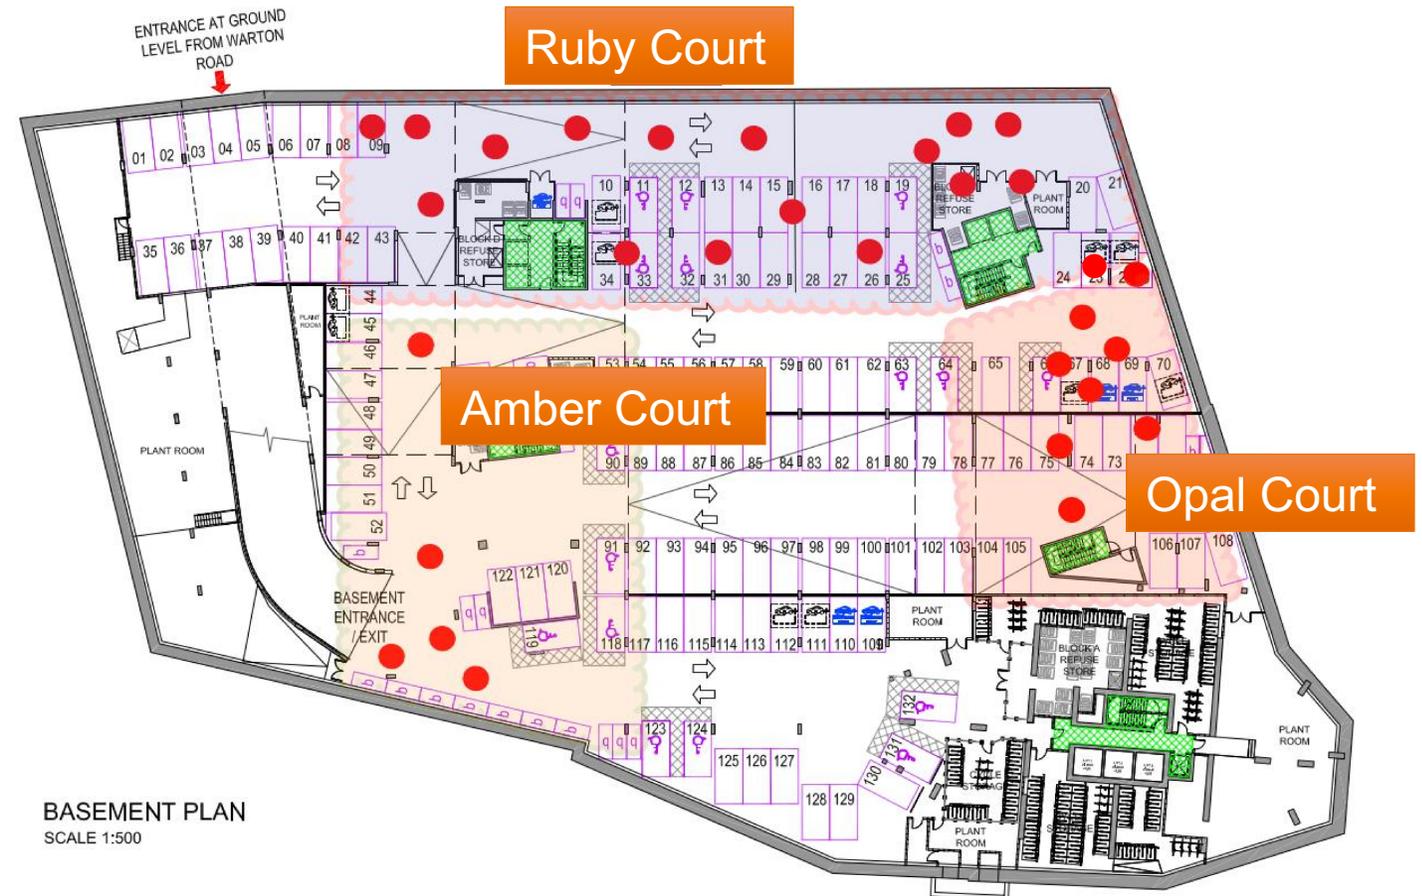
- Column to slab punching shear, slab combined punching shear and bending

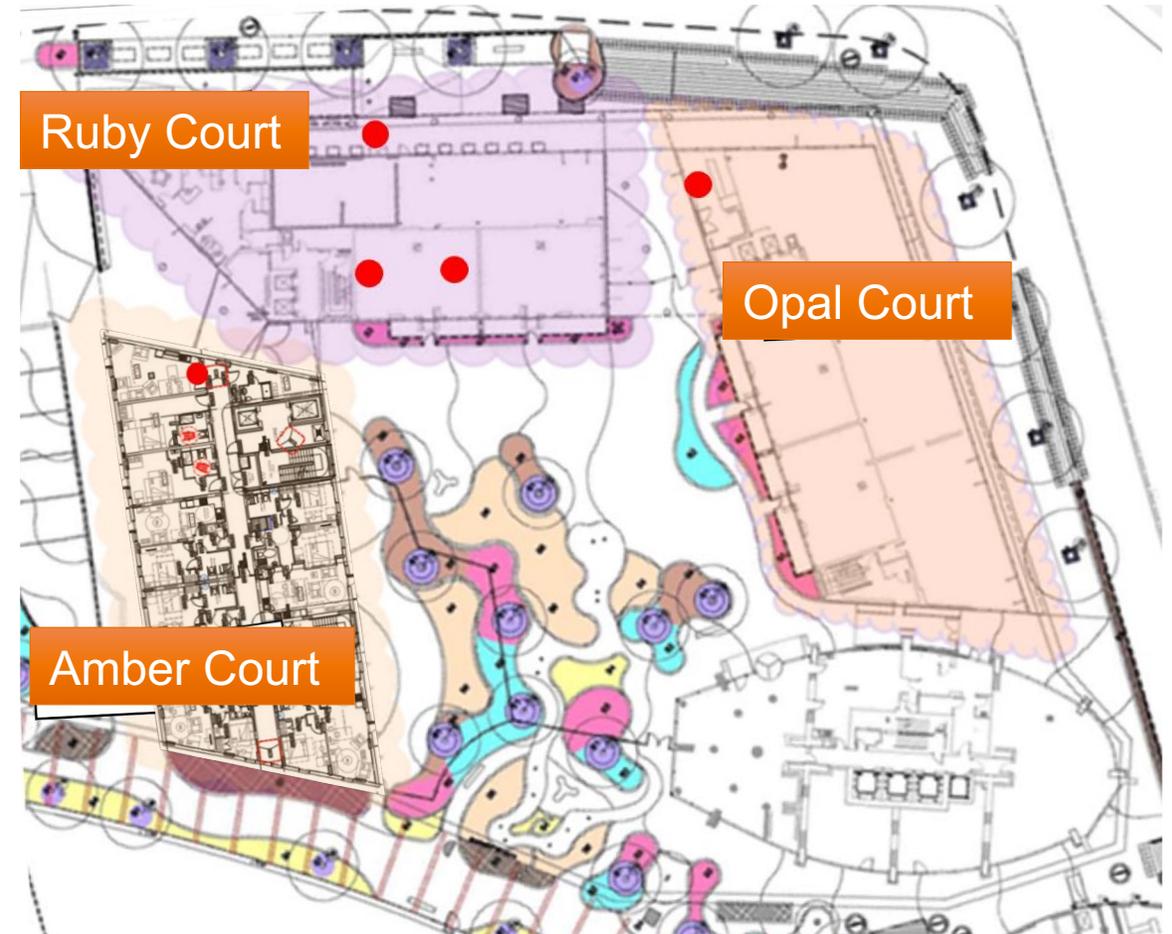
- Column to slab punching shear, slab combined punching shear and bending

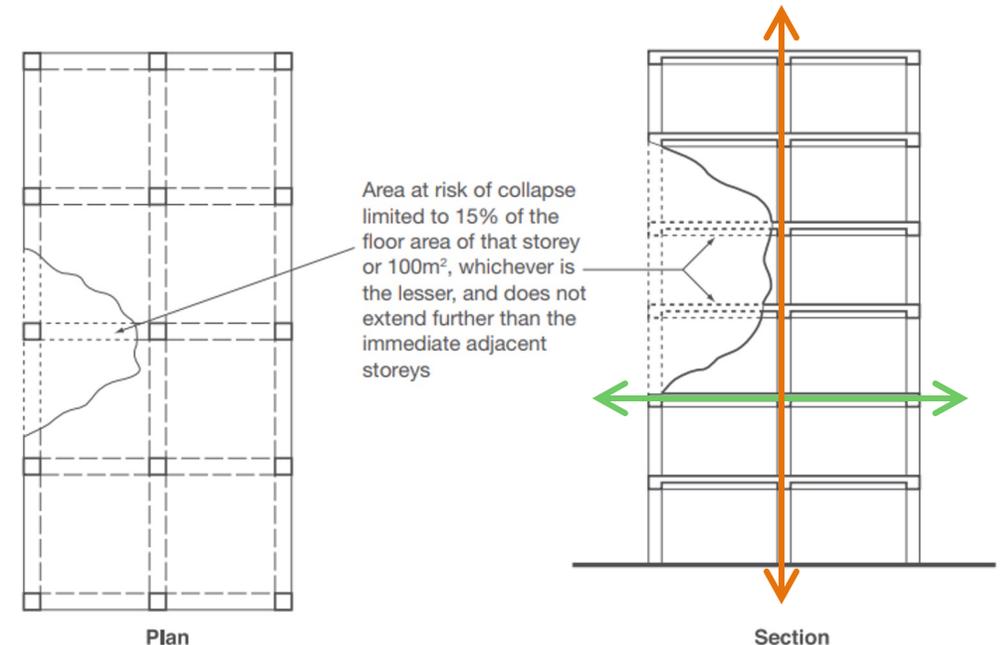
Diagram 24 Area at risk of collapse in the event of an accident

In the event of accident/structural failure the global collapse of structures is limited by designing the structure against what is termed as disproportionate collapse.

This involves ensuring that the building structure is both vertically and horizontally tied together adequately.

Alternatively critical structural components, known as 'Key elements', are designed for accidental loading resulting from gas blasts, vehicle impact etc.

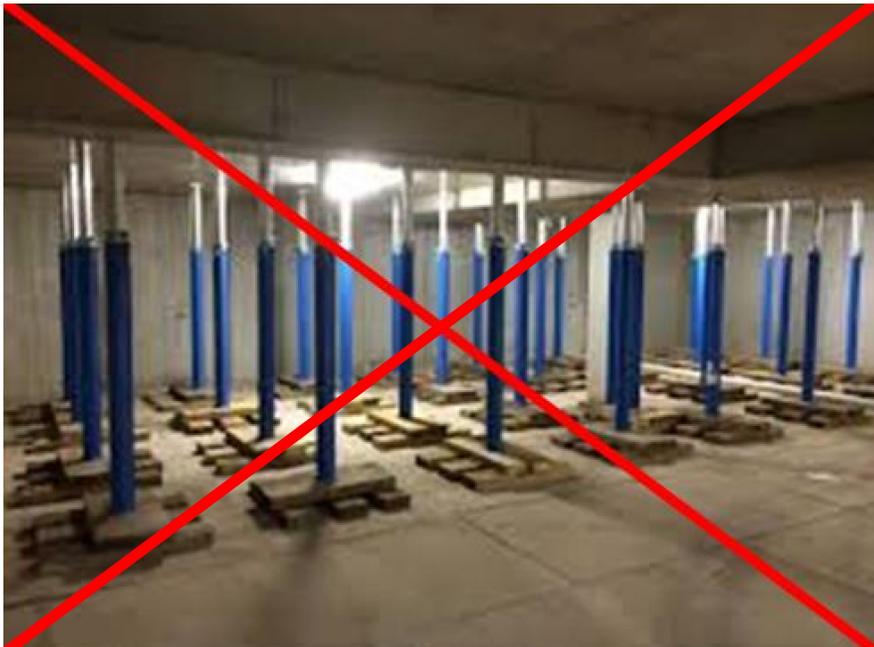
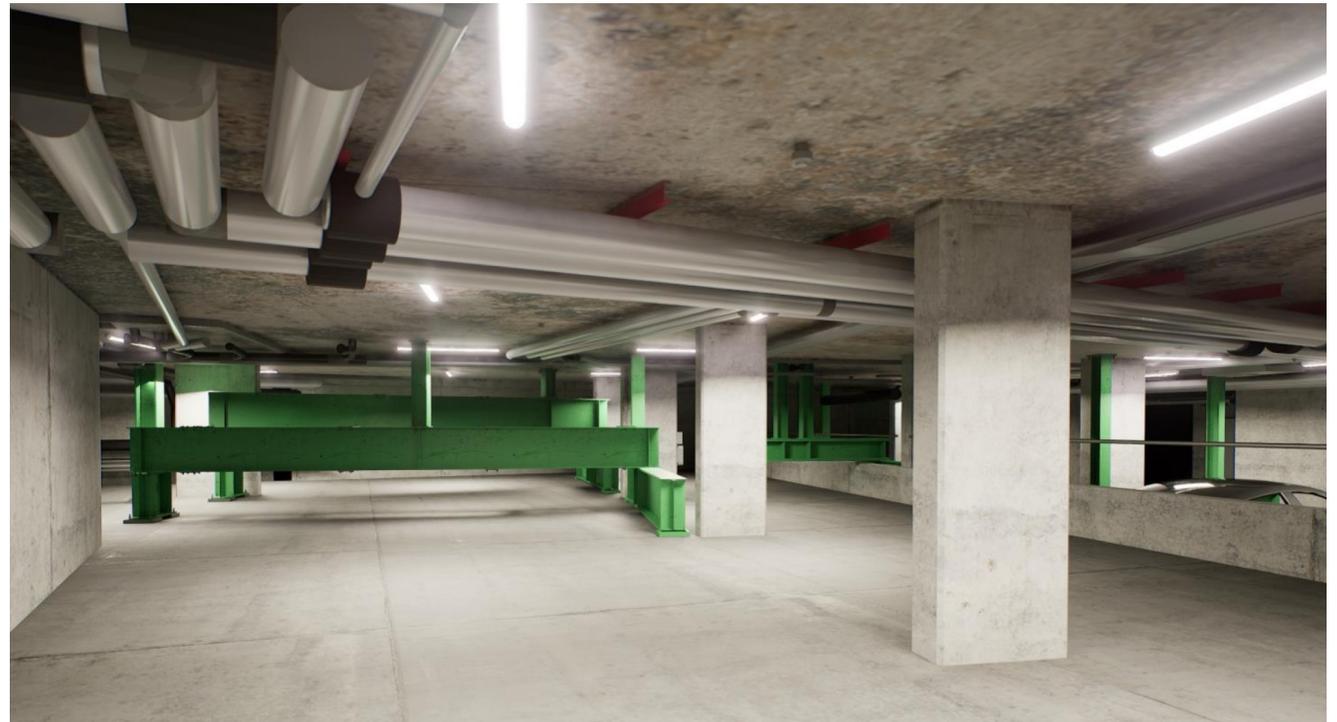
Temporary/Interim propping solution

- A temporary propping solution has been developed by the Original Structural Design Engineers. This consists of bespoke fabricated deep steel beams propping the underside of the ground (basement ceiling) slab
- The steel beams will be installed tight to the underside of the ground floor slab. They are designed, in a failure situation, to support column loads from above and distribute them to the existing foundations
- The Original Structural Design Engineers have proposed a design they consider will mitigate the current risks on a temporary basis, there are some areas that we are seeking further clarity on due to high utilisation
- Whilst considered to be a temporary/interim proposal the propping solution should be designed with the structural capability to support column loads permanently

Not a series of ‘acro’ props

New transfer beam structure shown in green

- The temporary/interim propping solution has the structural capability to support column loads permanently. This is not however, a permanent remedial solution
- This is to allow residents to move safely back home with certainty about the longer term
- It is NHG's requirement that any long-term permanent remediation solution must have the capability to be installed without the need for further future mass relocation of residents
- A long-term remediation solution to the areas of concern has been requested by NHG and their Technical Advisors from the Original Structural Design Engineer
- To date this has not been provided by the Original Structural Design Engineer

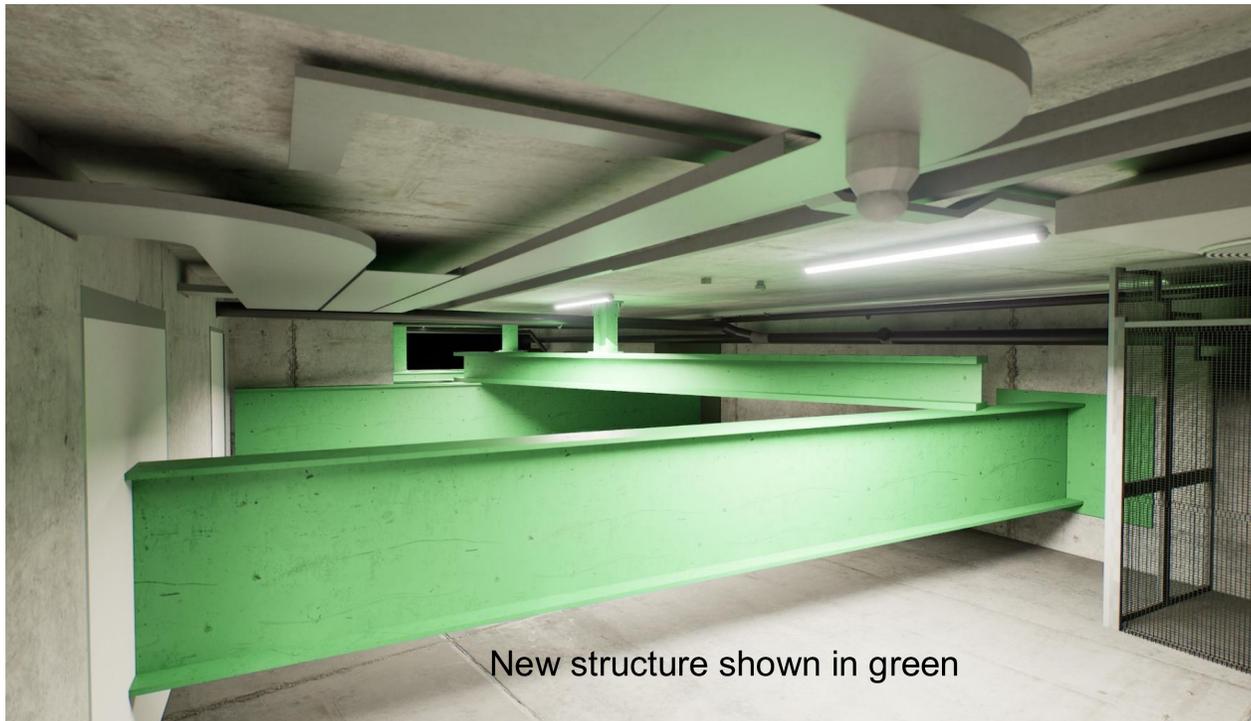
Temporary/Interim propping solution

New structure shown in green

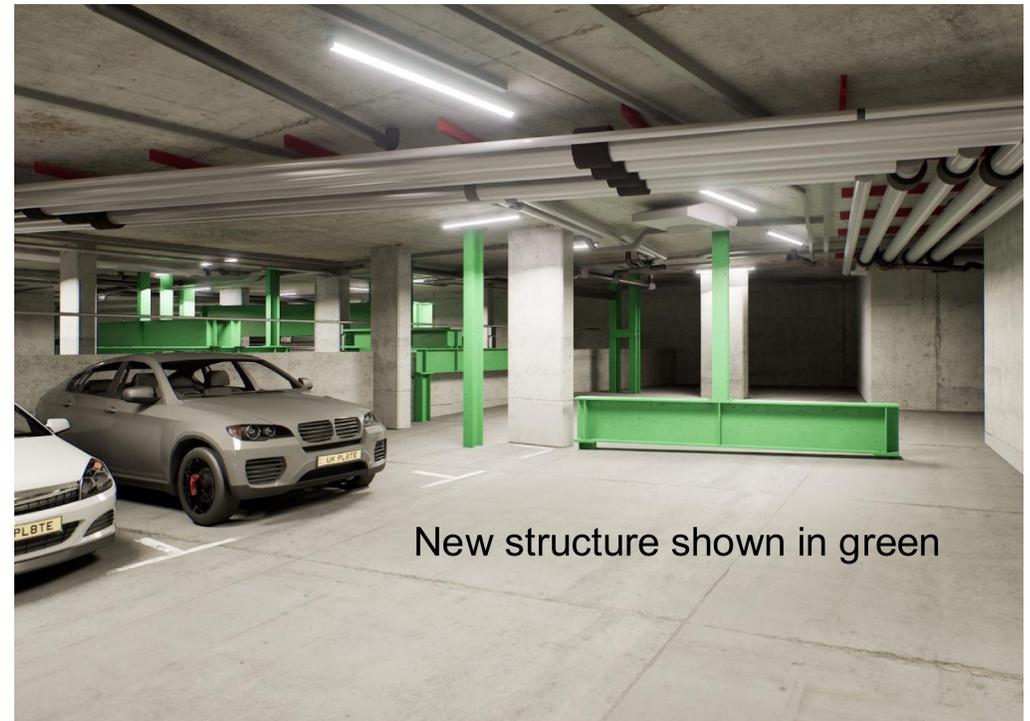
New structure shown in green

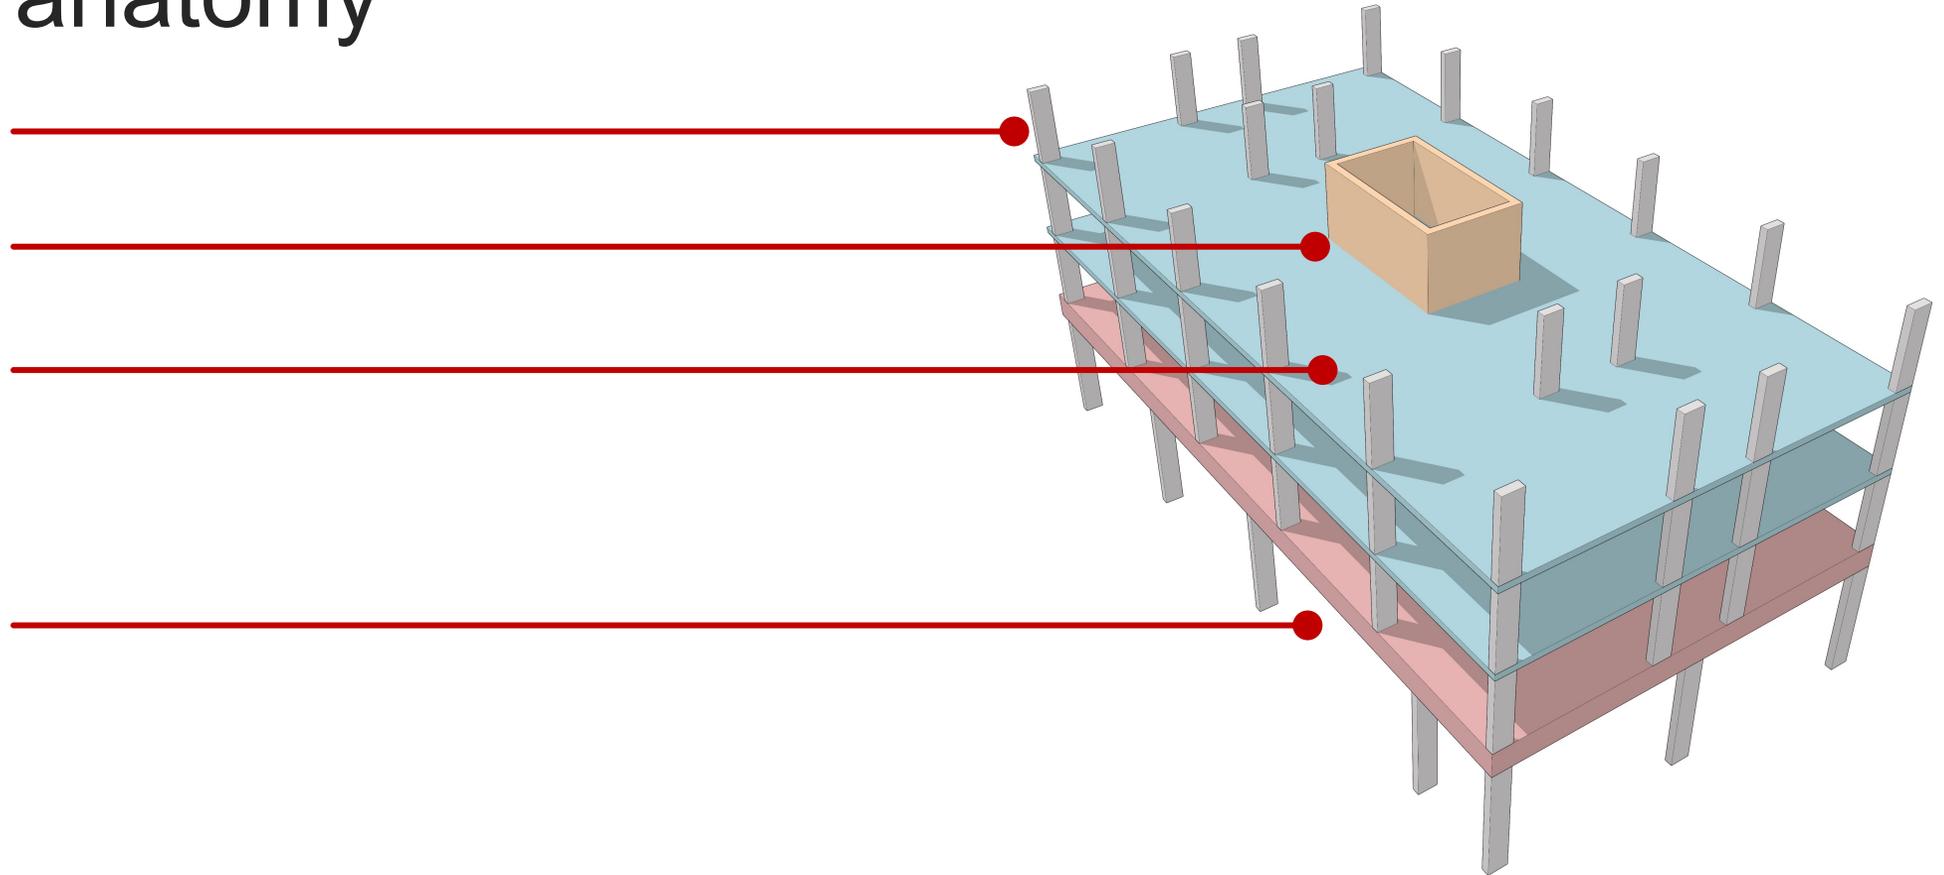
Column

Core

Slab

Transfer slab

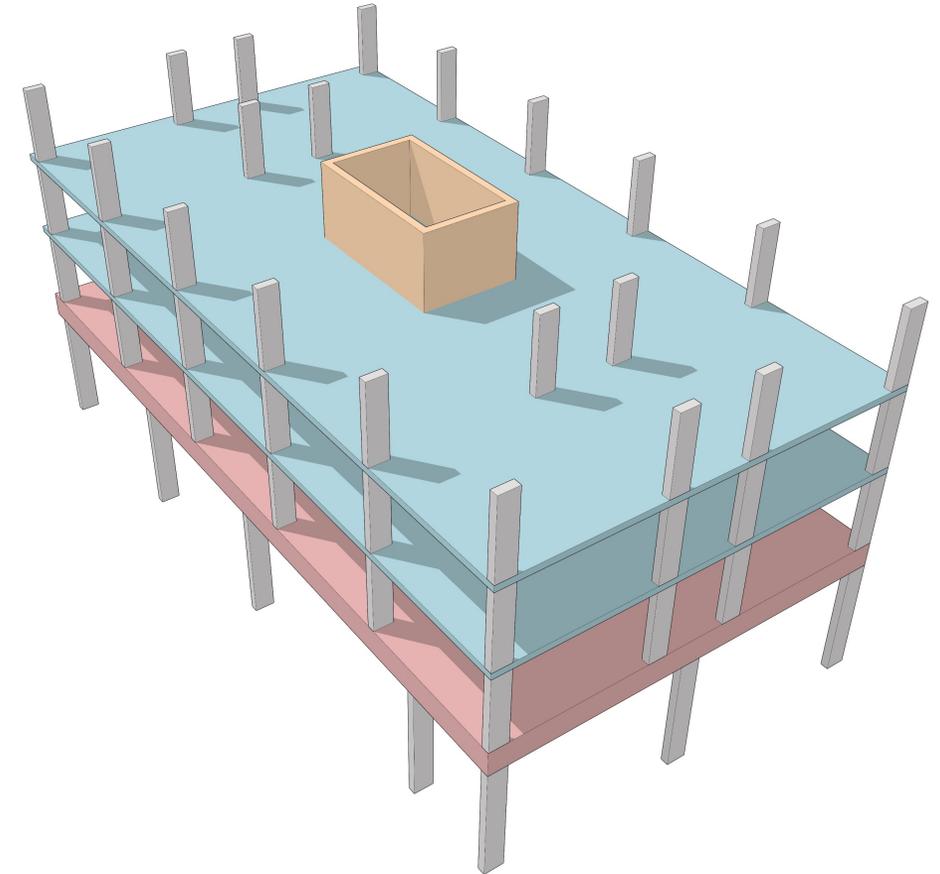
- All Blocks are reinforced concrete (RC) frames.
- They rely on vertical columns supporting horizontal concrete slabs.
- The slabs are typically what is termed as 'flat slabs' meaning they are self supporting and not reliant on beams providing vertical support.
- The buildings are stabilised against wind using concrete walls, clustered around vertical circulation locations such as staircases and lifts.

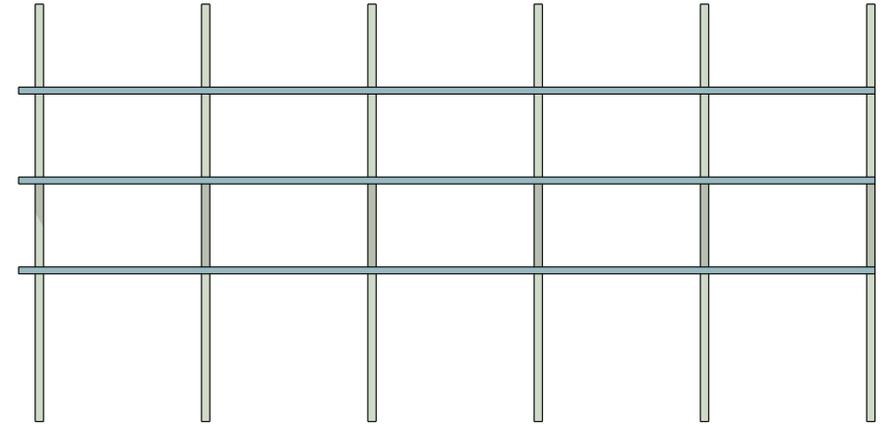
Vertically aligned

- Opal, Ruby and Amber Court is reliant on transfer slabs.
- This is not an unusual form of structure for this type of building.
- It is often used to accommodate different floor layout requirements between basement/ground areas to those above such as residential layouts

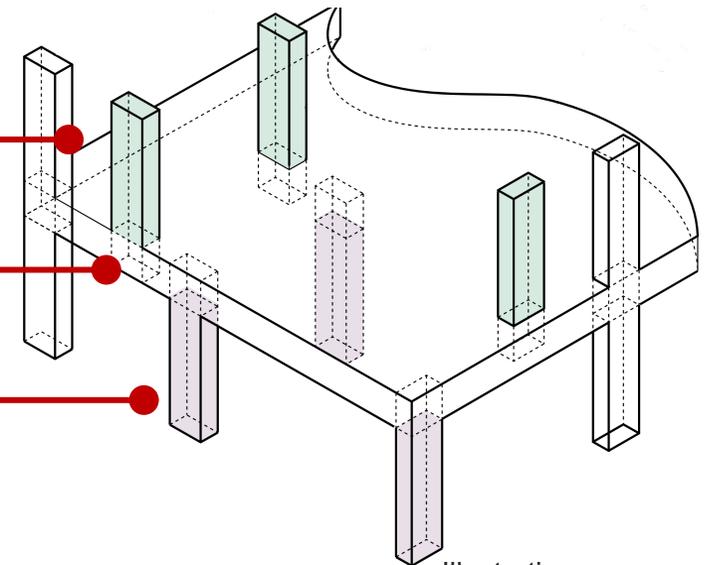
Transfer slab nomenclature and punching shear

Planted Column

Transfer slab

Supporting column

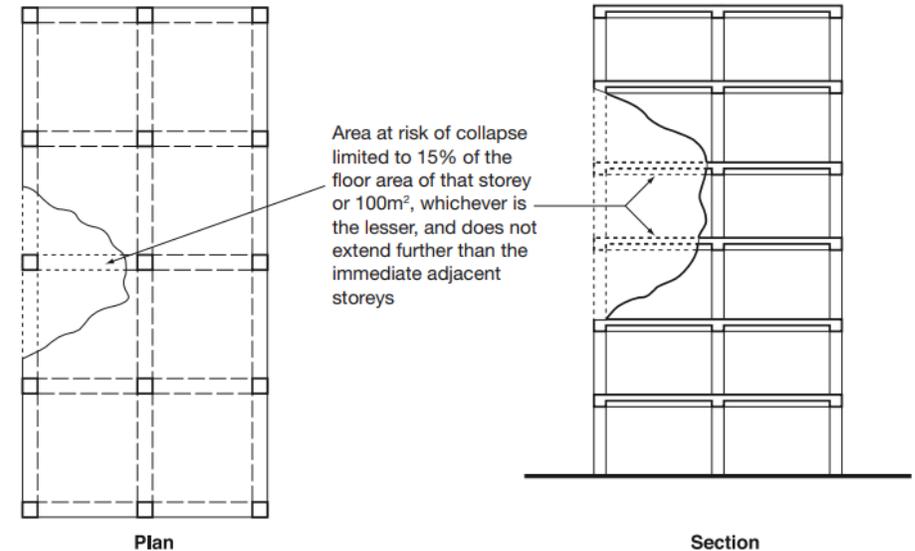
Diagram 24 Area at risk of collapse in the event of an accident

In the event of an accident/structural failure the global collapse of structures is limited by designing the structure against what is termed as disproportionate collapse.

This involves ensuring that the building structure is both vertically and horizontally tied together adequately.

Alternatively critical structural components, known as 'Key elements', are designed for accidental loading resulting from gas blasts, vehicle impact etc.

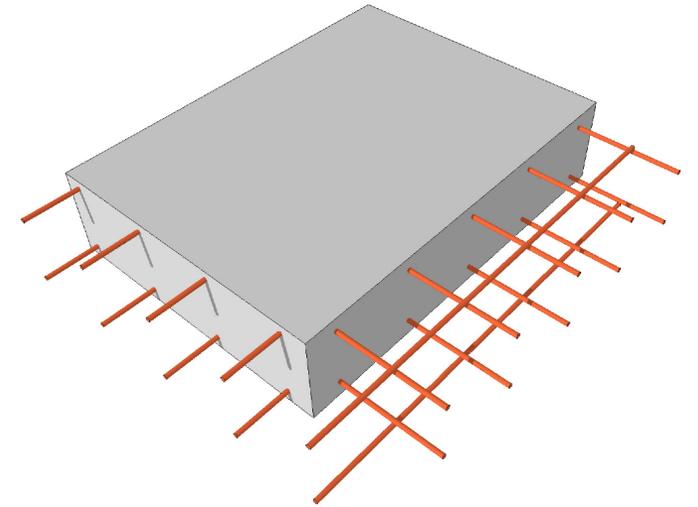
Reinforced Concrete

- Concrete is good in compression (being squeezed)
- Concrete is poor in tension (being bent and stretched)
- Steel is strong in tension

Combining the two materials creates a material which is strong under compression and tension

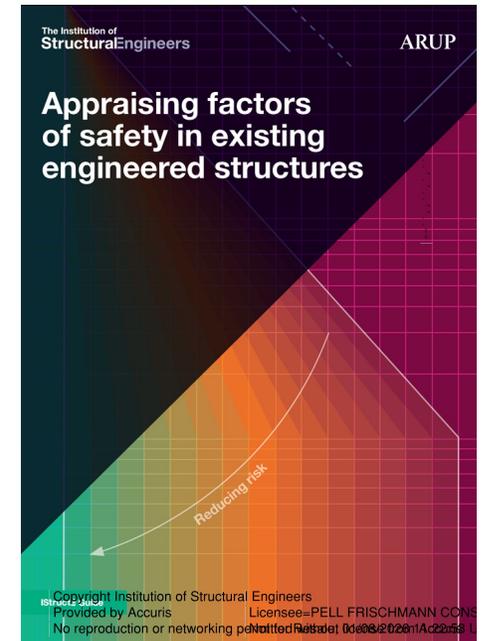
- This was based on the evidence provide by the original structural engineer.
- Additionally, structural performance concerns were assessed against a technical paper published by the Institution of Structural Engineers 'Appraising factors of safety in existing engineered structures'. This demonstrated that continued occupation of the buildings represented a very high (unacceptable) risk.
